PHOTOGRAPHIC INTERPRETATION MEMORANDUM

**RECONSTRUCTION OF
NORTH VIETNAMESE
THERMAL-ELECTRIC
POWERPLANTS**

NPIC/R-82/69

SEPTEMBER 1969

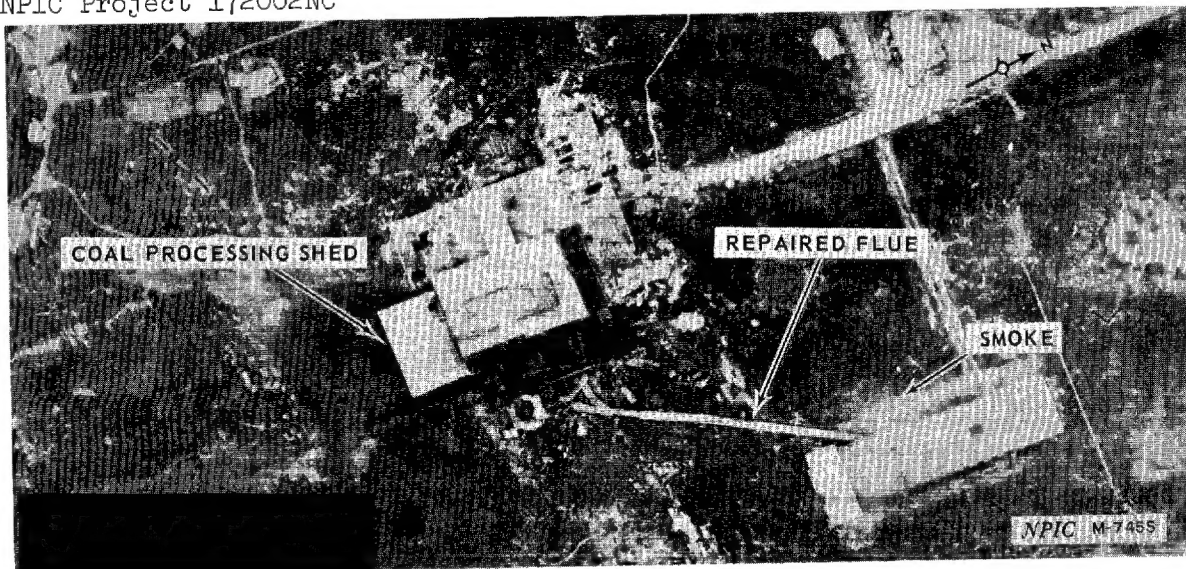
FIGURE 2. THERMAL-ELECTRIC POWERPLANT, BEN THUY, NORTH VIETNAM

The Ben Thuy TPP, heavily damaged in mid-1965, was subsequently restored, and was damaged again in early 1968. The latest reconstruction of the plant has continued since initial repairs to the disposal system were observed [REDACTED]. Boiler testing may have occurred as early as [REDACTED] but was not confirmed until [REDACTED]. The repair of all essential plant components has now been completed and the observation of smoke rising from the flue system indicates that it is operational (Figure 2).

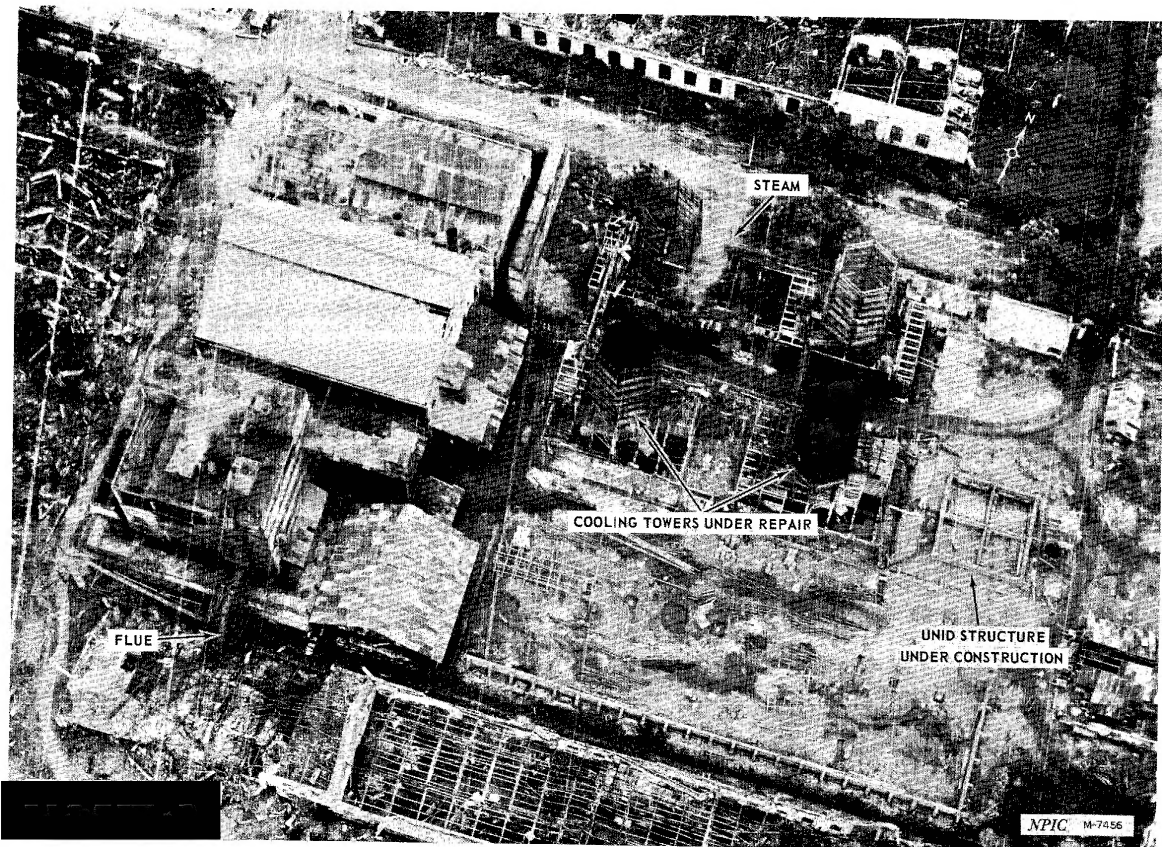
FIGURE 3. THERMAL-ELECTRIC POWERPLANT, NAM DINH, NORTH VIETNAM

The first evidence of major exterior repairs to any of the thermal-electric powerplants in North Vietnam has been observed at Nam Dinh. Previously, only minor repairs to the roofs and coal sheds have been observed. At the Nam Dinh TPP, two of the four heavily damaged cooling towers are being repaired (Figure 3). A new coal processing and storage building and an unidentified structure are also under construction. Apparently this plant has been operational since initial repairs were completed in [REDACTED].
